Release Notes
nVent/Schroff firmware part number 63998-53480
Based on Pigeon Point Systems (PPS) firmware release V3.7.1.10 for ShMM-700

Release Date: March 16, 2022

The firmware package “63998-53480.zip” contains Firmware release V3.7.1.10 for the **ShMM-700**. The PPS supplied APP image has been modified by nVent/Schroff to adapt the firmware to nVent/Schroff ATCA shelves. The kernel and RFS images have not been modified and are identical to the PPS kernel and RFS images. The U-boot environment has been modified to reflect the necessary non-volatile system settings for this firmware running on nVent/Schroff shelf managers. The nVent/Schroff part number for this firmware release is 63998-53480.

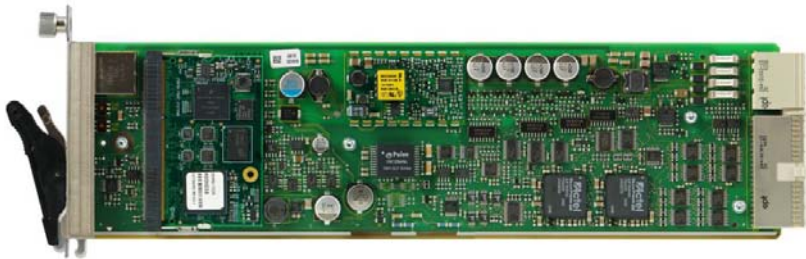
Photo	Type	RC2-variable

The table below shows the nVent/Schroff shelf manager versions, please identify your shelf manager type. You will need the corresponding RC2-variable later in the upgrade process.

Note: Please make sure that the rc2 variable is set correctly. A common problem that causes the Shelf Manager to not work properly is to set the rc2 variable incorrectly.
